River Bank Lofts
550 North Kingsbury Street
Chicago, Illinois

**CRITICAL EXAMINATION
REPORT OF THE EXTERIOR
WALLS AND ENCLOSURES**

April 4, 2003

SCHOENGART ASSOCIATES, INC.
Architects + Planners

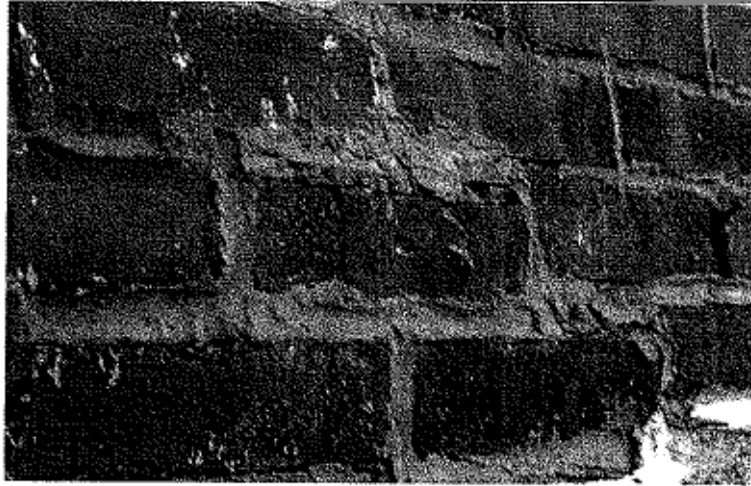
Figure 3. Cracked, weathered and loose mortar joints. Typical condition observed on the east, west and south elevations masonry surfaces.

1. Remove and replace with new masonry areas of damage or deterioration such as severe cracks, spalls, or out of plumb masonry. Particular attention should be directed to the areas above the windows on all facades and the parapet wall on the east and west elevations.
2. Grind out a minimum of 3/4" and tuckpoint 100% of all mortar joints.
3. Repair deteriorated masonry vertical joints at the corners of the garage parking on the east elevation.
4. Remove and replace deteriorated sealant/mortar joints around limestone elements.
5. Remove and replace any weathered or deteriorated window caulking at the perimeter of the window openings. The work should include cleaning, priming, and a new resilient sealant applied.
6. Repair as needed any deteriorated steel shelf angles.
7. Clean and paint as needed balconies metal railing and components.

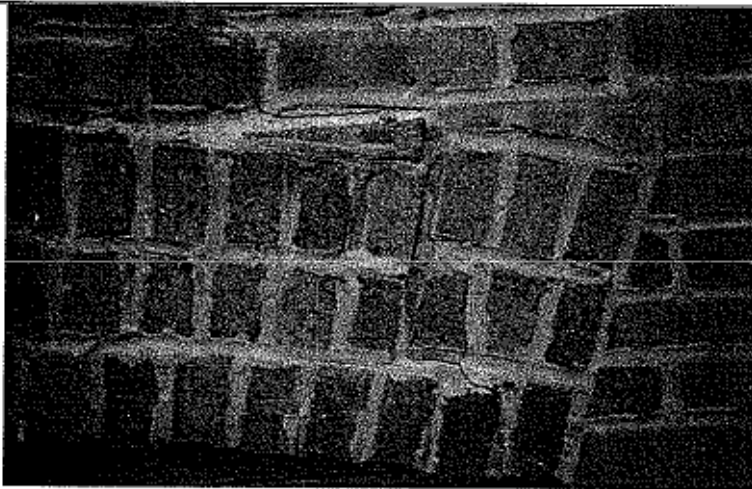
Figure 4. Cracked and loose mortar joints below window sills. Typical condition found on the east, west and south elevations.

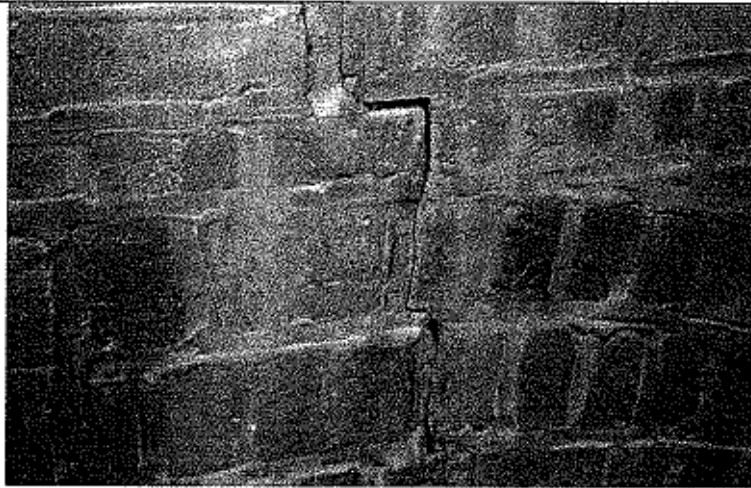
Figure 5. Cracked and loose mortar joints above windows. Surface appears to have shifted. Condition is typical for areas above windows on the east, west and south elevations.

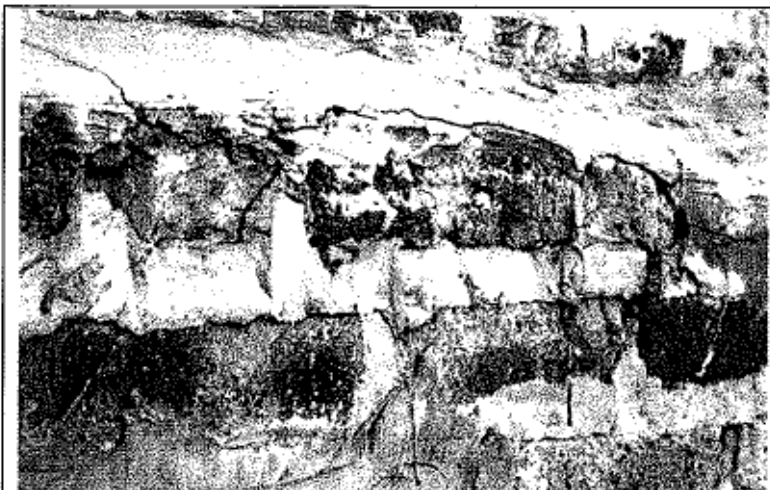
Figure 7. North elevation parapet wall.
Cracked, loose and weathered mortar joints.

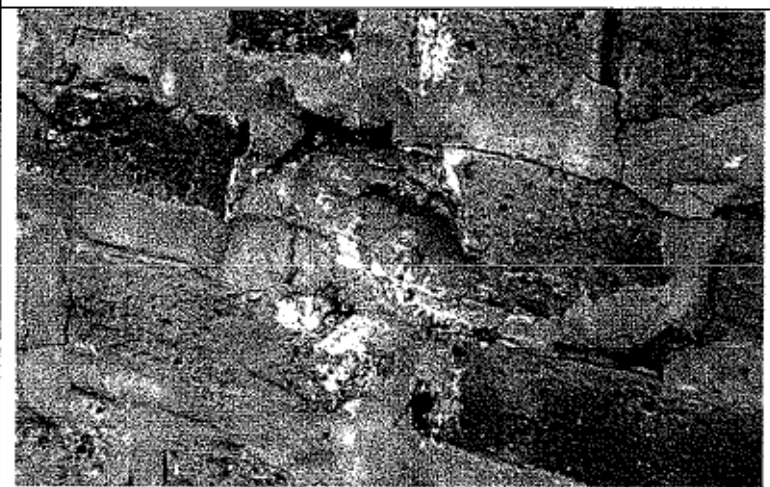
Figure 8. North elevation parapet wall.
Cracked and loose mortar joints.
Cracked and spalled surface.
Typical condition for the entire elevation.

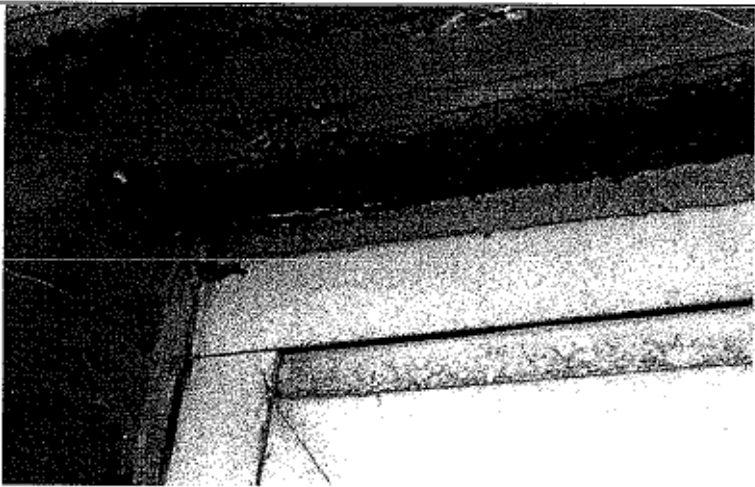
were observed out of plumb. Mortar joint cracks were also observed below window sills and at window brick arches on all elevations. At the brick arches, the surface appeared to have shifted. In addition, bricks and mortar joints in the parking garage piers were observed cracked and loose (See figures 1 through 6). The common brick surface and mortar joints on the north elevation were found to be in need of maintenance or repair work. Cracks and surface spalls in the masonry as well as weathered and loose mortar joints were observed throughout (See figures 7 and 8). Finally, some of the steel shelf angle appeared to be corroded at the top floor on the east and west elevations. (See figures 9 and 10)

Figure 10. Corroded steel shelf angle at the top floor on the east elevation. Previously painted shelf angle is deteriorating, the result of no flashing details.

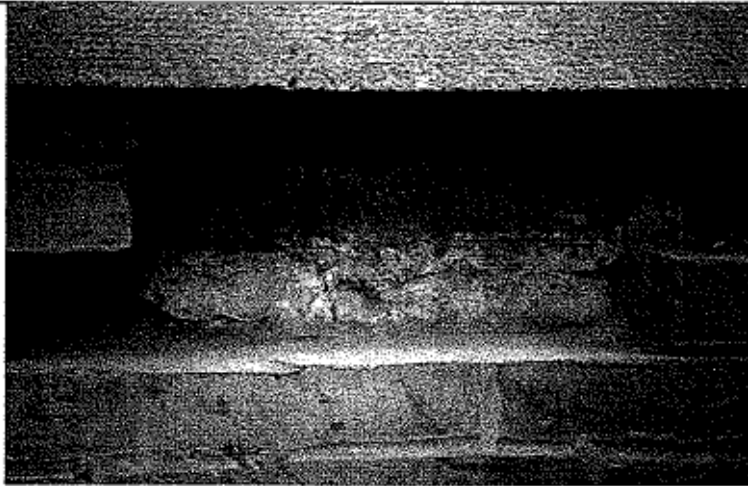
Examination of Substrates - Inspection openings provided by the contractor during the inspection at areas with no external visible distress, revealed the typical wall construction to be brick masonry anchored into backup masonry. The backup masonry appeared to be in sound condition. They also revealed steel shelf angles and balconies anchorage in sound condition. See figures 11 and 12)

Figure 11. Inspection opening revealed backup brick in sound condition.

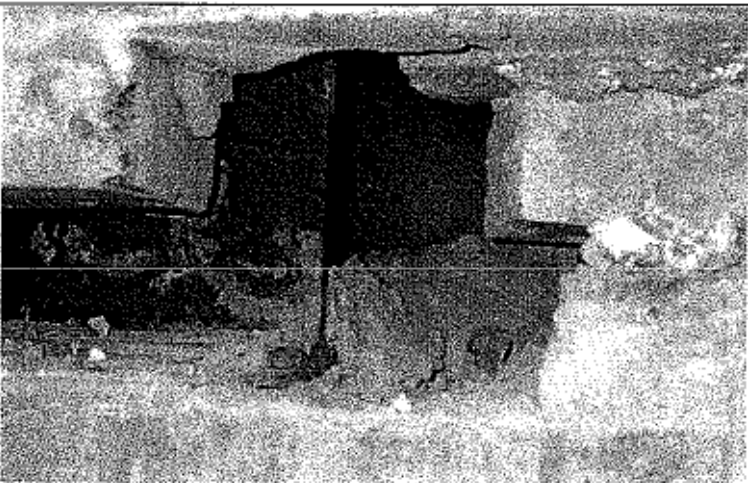
Figure 12. Inspection opening revealed steel angle in sound condition.

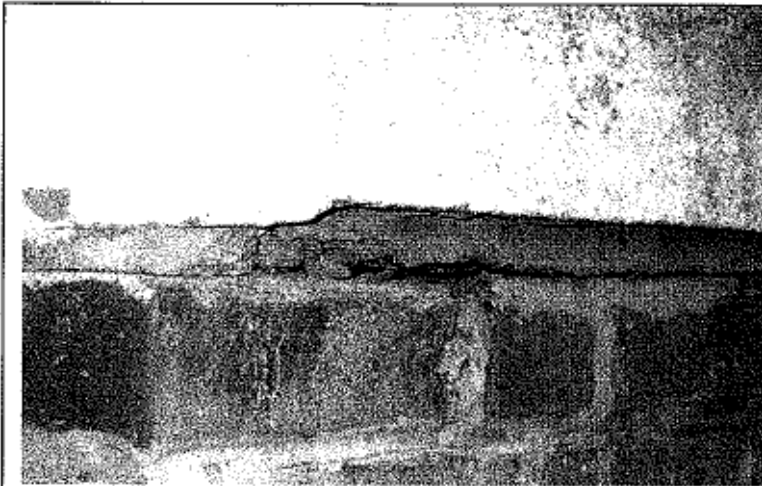
Limestone elements, including windowsills, decorative pieces, and coping stones on the garage structural were visually surveyed and sound tested with a masonry hammer. Some minor spalls and cracks were observed on all facades. The most widespread deficiency was the poor condition of the mortar joints around limestone elements. They were observed cracked, weathered and opened. (See figures 13 through 15)

Figure 13. Deteriorated mortar joints around limestone elements. Typical condition around most limestone elements on all facades.

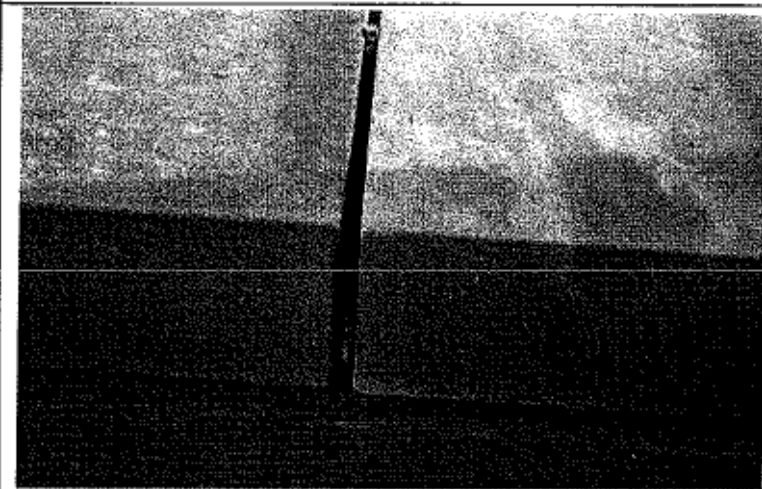
Figure 14. Cracked and opened mortar joints at limestone caps on parking garage walls.

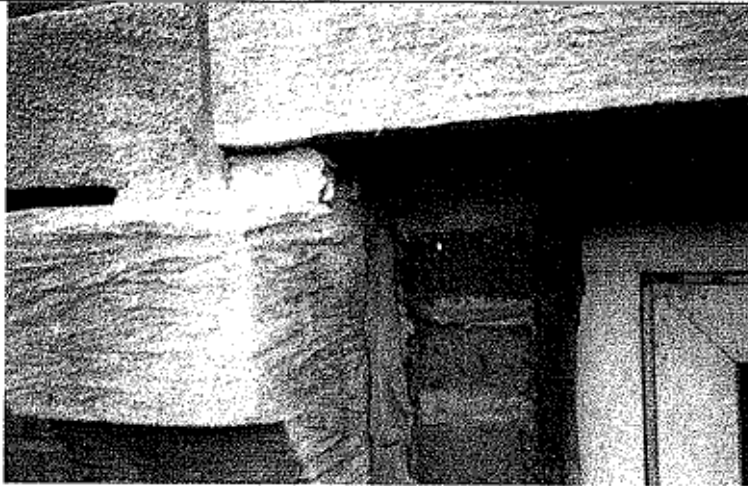
Figure 15. Cracked, weathered and opened mortar joints at limestone elements.

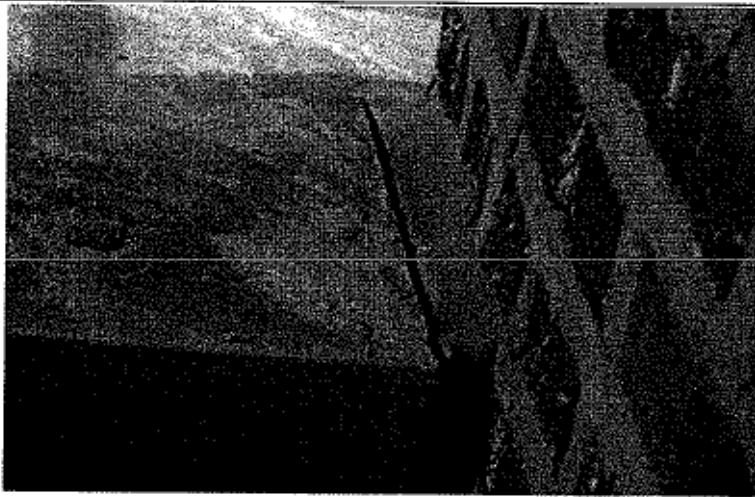
Window units were surveyed and examined for broken glass, missing elements, and loose or non-bonding materials. The aluminum frame and glass window units appear to be in sound condition. However, the caulking around the perimeter of window openings were found to be weathered, non-bonding, and/or completely missing throughout all facades. In addition, the sealant/mortar around limestone windowsills appeared to be cracked, weathered and deteriorated. (See figure 16 through 18)

Figure 18. Opened and non-bonding sealant joints around limestone joint.

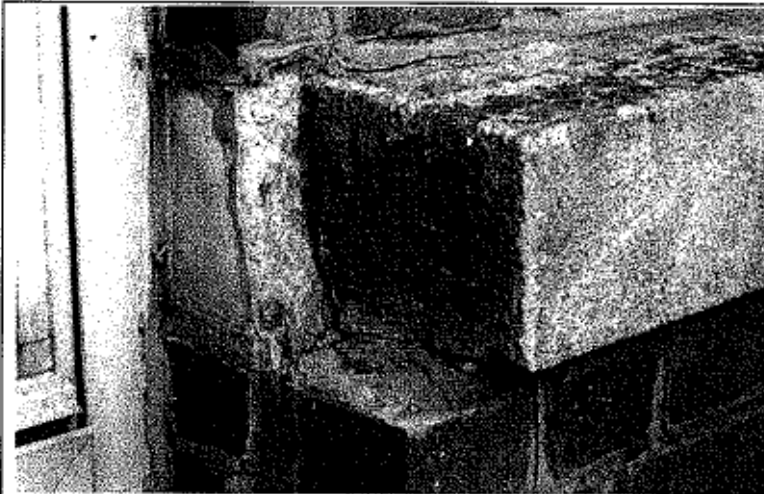
Concurrently with the critical facade examination, all loose, delaminated or dislodging materials were removed by the contractor as a temporary "make-safe" solution. (See figures 19 and 20)

Figure 19. Delaminated and loose limestone surface removed by the contractor during the critical examination on the west elevation, as a temporary "make-safe" solution.

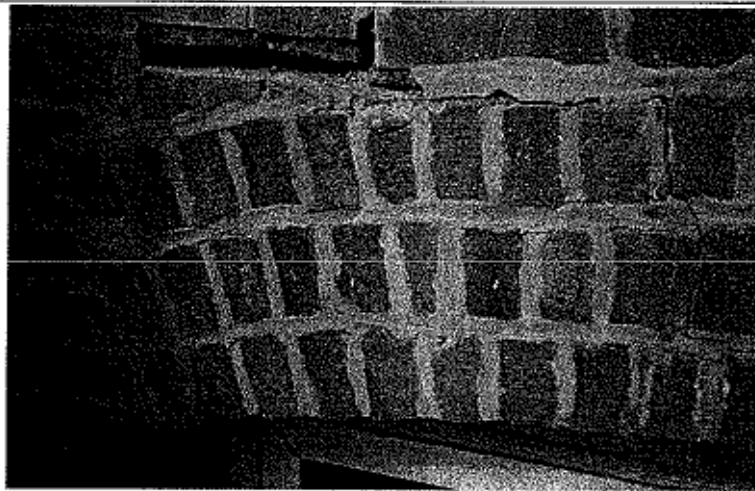
Figure 20. Delaminated and loose brick and mortar surface removed by the contractor during the critical examination on the south elevation, as a temporary "make-safe" solution.
